## Preventive Maintenance Inspection

11/07/2008

This report was prepared by TS Thermal Survey Ltd using a  
Flir PM675 ThermaCam.

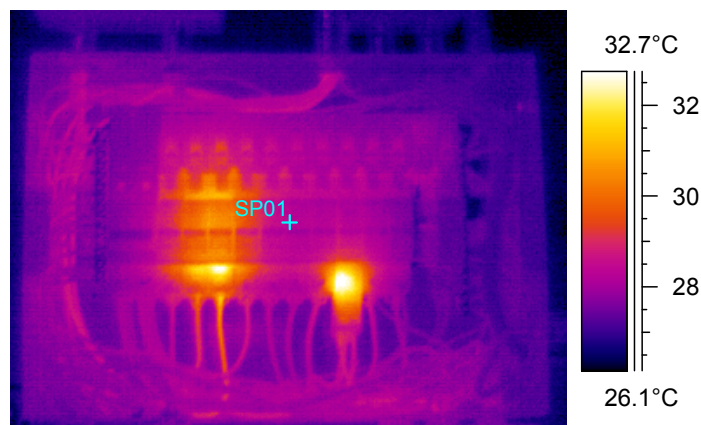
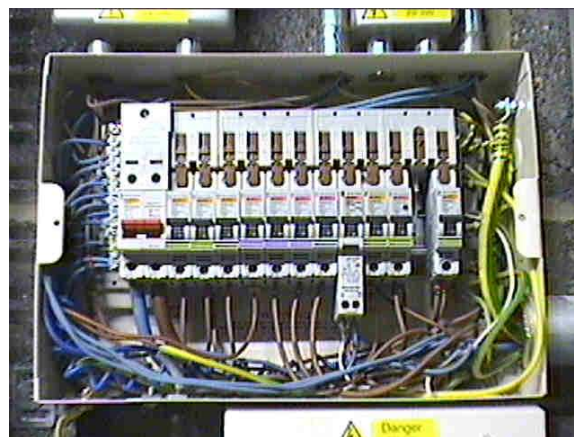
Car park lighting distribution panel, 4th floor

Right hand hot spot is an energised contactor, and does not indicate a fault. Left hot spot indicates a poor connection, which appears to be due to pinched wire insulation. Urgent attention is required to rectify this fault.

1. Pinched insulation in a terminal connection on a small distribution panel. This requires urgent attention.
2. A heavily loaded switch. This was indicative of an issue elsewhere on the circuit causing the heavy current draw. Further investigation was needed to indicate why the circuit was in use.
3. Phase imbalance on a 3 phase supply, requiring further investigation.
4. Underfloor electrical heating, working correctly.

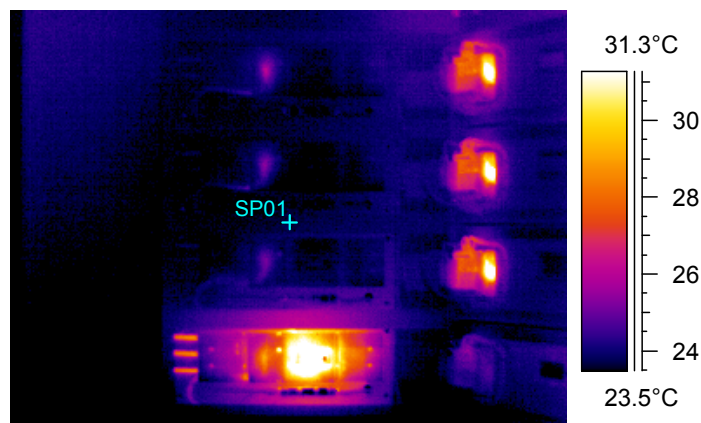
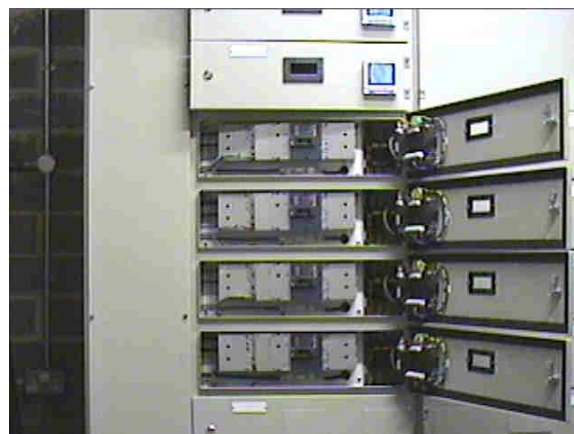
Plant room, Main power switches

The lower panel indicates considerable loading. Further investigation shows that this circuit covers the fire sprinkler pumps, which should not have been running at the time. The cause of this requires investigation.

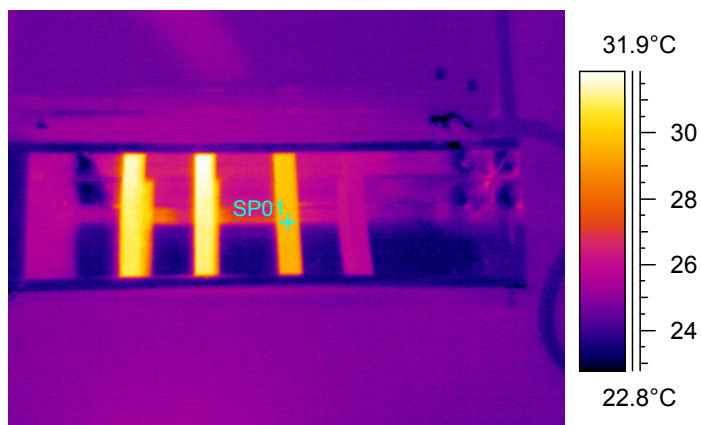
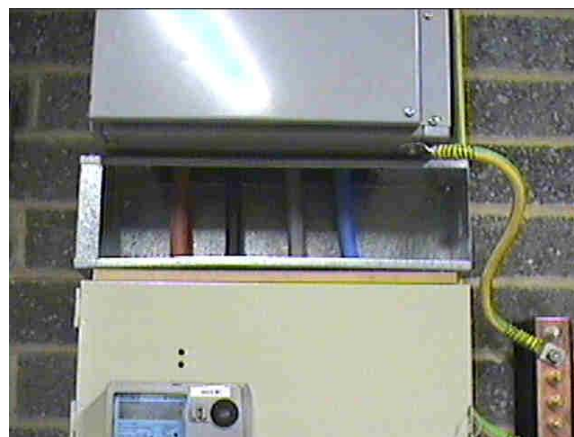
Plant room, Main incoming 3 phase supply

Mild phase imbalance - checked with a clamp meter and found to be variation from 149-165 Amps between conductors.

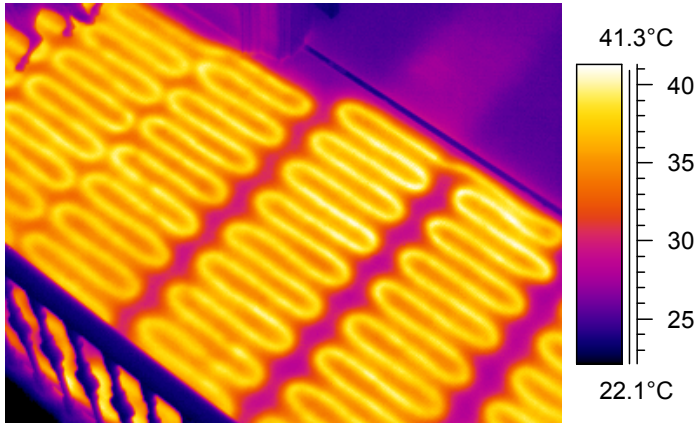
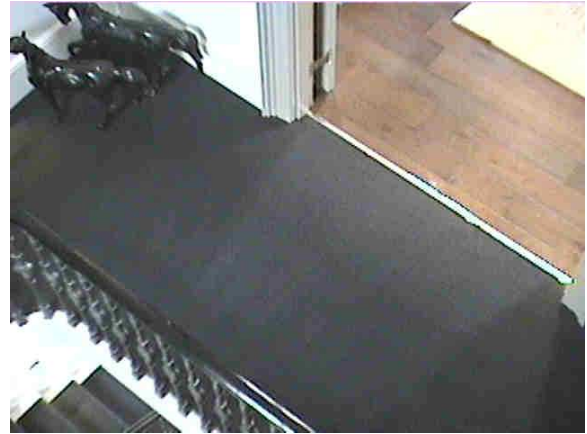
Electrical underfloor heating elements on a 1st floor landing

No fault found - matting has been laid correctly.
